CU Boulder Panel Test Update

Sebastian Vazquez and Sebastian Seeds

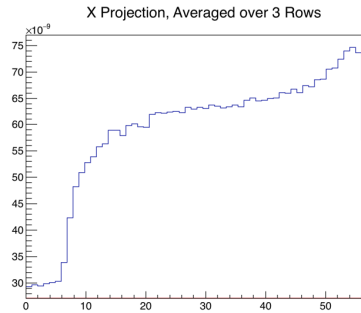
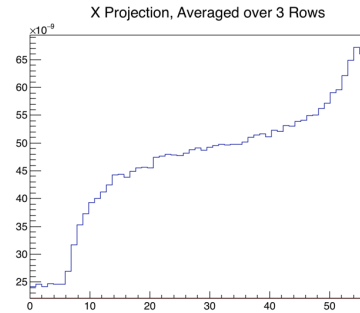
A systematic light gradient was noted in the panels sent to us.

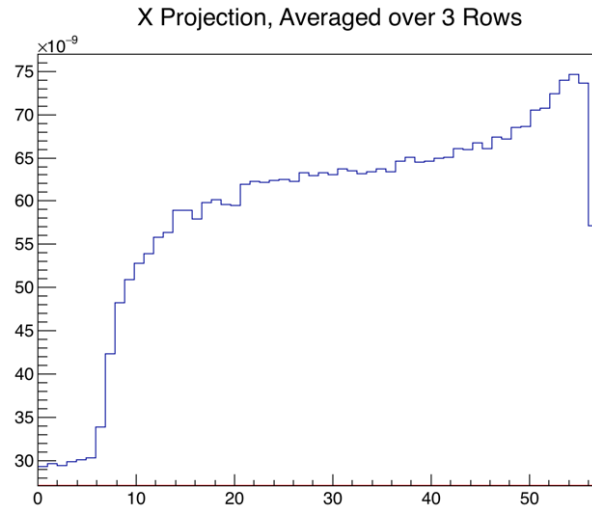
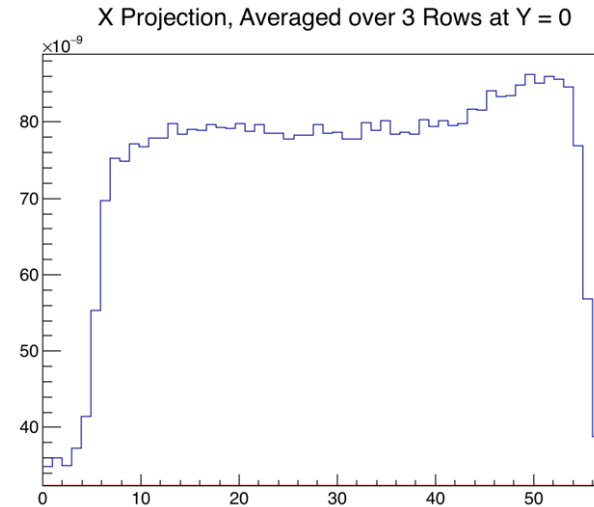
It was found that panels lacking the diffusive coating displayed a much smaller gradient than the coated panels.

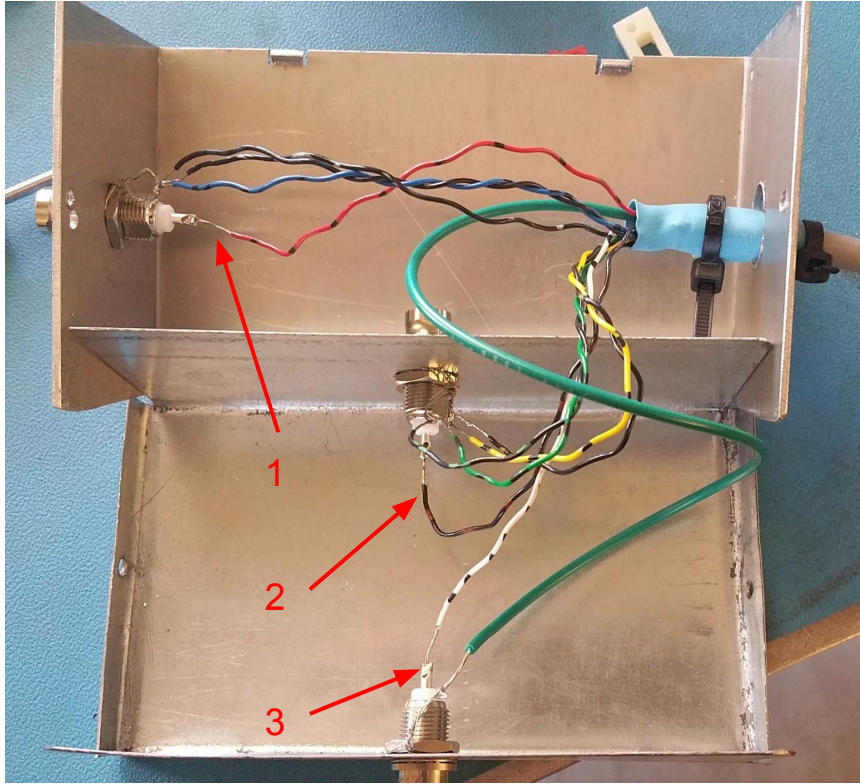
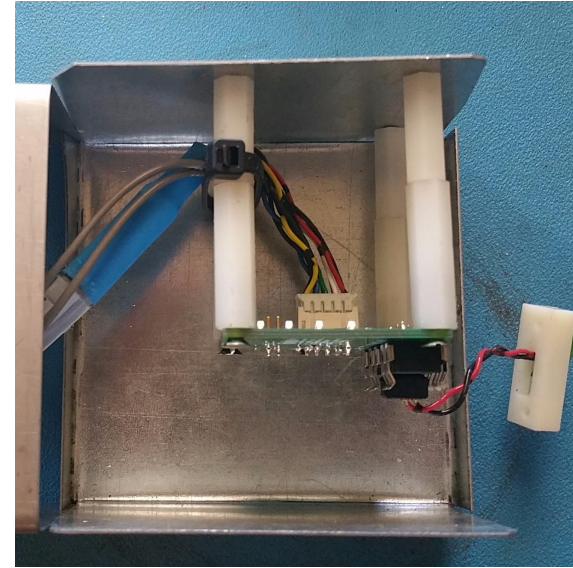
New Pre-Amps

- Pre-amps have been assembled.
- However, the pre-amps are drawing an abnormal amount of current when running at the specified voltages (high or low 6-20 mA).
- We are not seeing a signal out of the pre-amps and are concerned that something is malfunctioning.
- Gen 3 mounting brackets are currently being printed.

1. Negative Bias
2. Black/Red: +8V @ 49mA (mA by spec)
3. White/Black: -5V @ -37mA (mA by spec)

We intend to find out what exactly is wrong with the new pre-amp/SiPM setup and fix it.

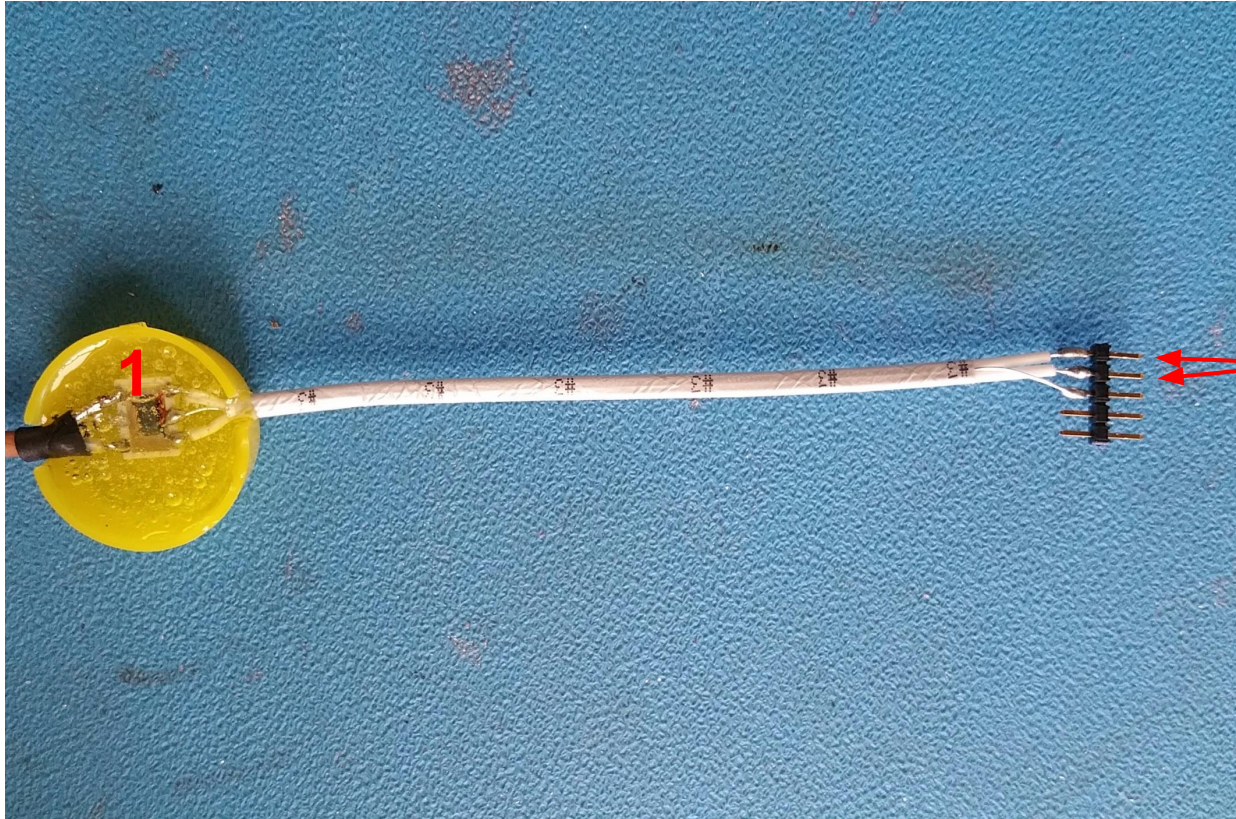
Lollipop Issues

Resistance between any two leads is zero.

We are concerned that something is shorting in the lollipop (1).

Resistance between any lead and the coax cable out is infinite.
